Home Inspection Report

xxxx NE Sample St. , Sammamish, WA 98074

Sunday March 29, 2015

Home Guide Inspections LLC
704 228th Ave NE Suite 261
Sammamish, WA 98074
425-238-8114
homeguideinspections@gmail.com

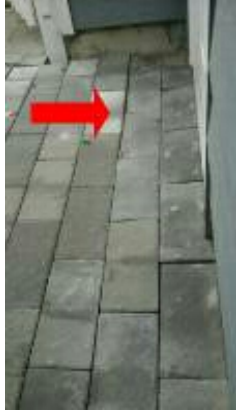
Comments Patio has settled in areas making an uneven surface/ trip hazard. Recommend repair

patio settling, trip hazard

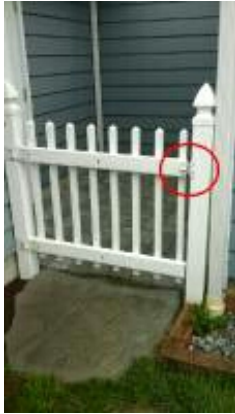
Comments Gate latch difficult to operate(see picture). Recommend repair

gate latch difficult to operate

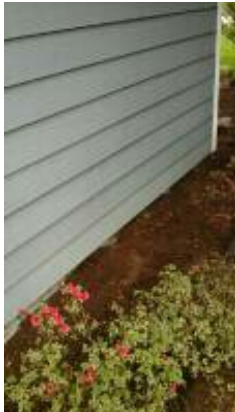
Negative Grade East South Wood in contact with/improper clearance to soil

Recommend 4"-6" of clearance between siding & soil

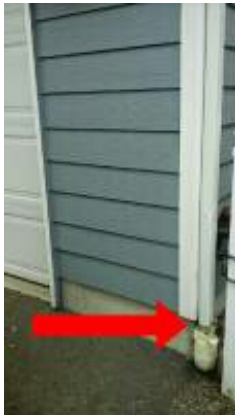
Comments Gutters were in overall adequate condition.
Extension recommend at Northwest downspout on garage (see pic) Recommend repair

Recommend downspout extensions

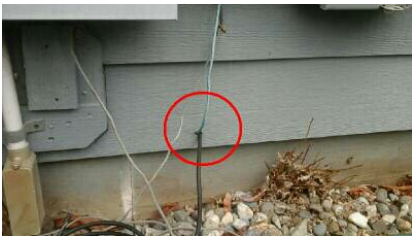
Comments Siding appeared to be all intact and in overall satisfactory condition.
Normal caulking maintenance recommended

Recommend sealing all utility holes

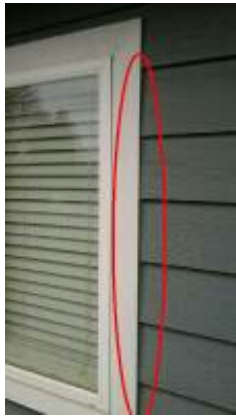
Comments Recommend caulking around windows, doors, corners, utility penetrations.

Repair/ replace caulking as needed.

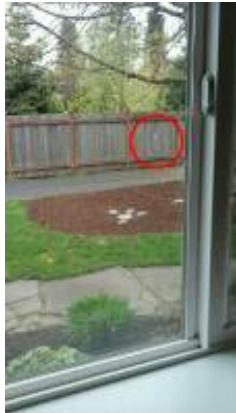
Comments Window chip present at North end living room wall, next to garage(see picture). Recommend repair

cracked / chipped window

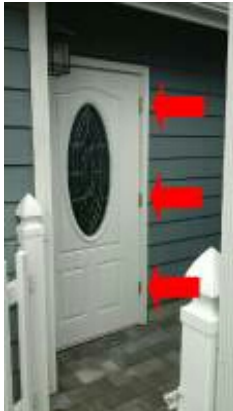
Comments Sliding glass door lock does not latch properly. Recommend repair
Patio door appears to be installed with hinges on the exterior side. Recommend repair /replace

Patio door installed with hinges on exterior

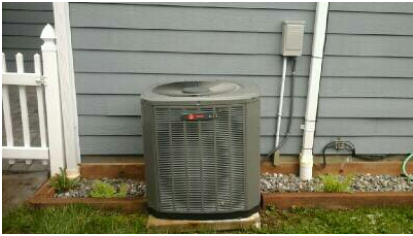
Level No Recommend re-level unit

Recommend leveling A/C unit

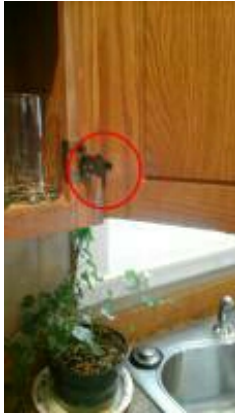
Comments Cabinet door(s) loose. Recommend repair

loose hinge

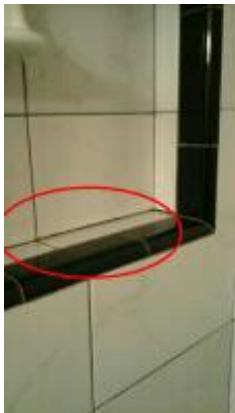
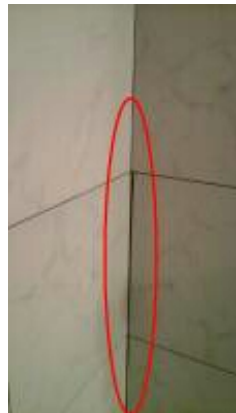
Shower/Tub area Ceramic/Plastic Condition: Satisfactory Marginal Poor Rooted floors
 Caulk/Grouting needed: Yes No
 Where: Caulking & grouting needed in shower area.

Recommend recaulking / regrouting shower

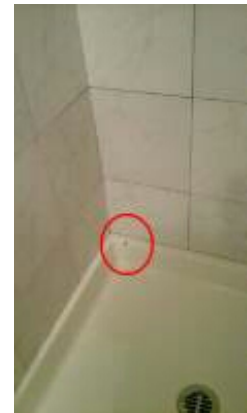
chip present on shower pan

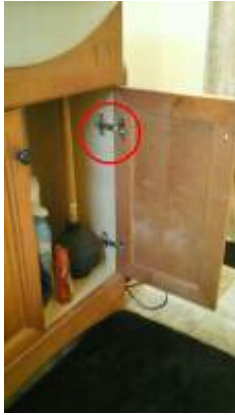
Comments Dimmer function on light switch was not operating. Recommend repair/replace.
 Light switch did not function. Recommend replacing light bulb. If still not functional recommend switch repair/replace.
 Cabinet door hinge loose. Recommend repair.

loose hinge

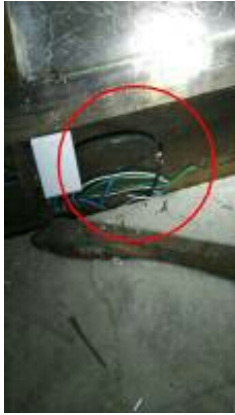
Comments Exposed wires should be capped or covered. Safety hazard, recommend repair by licensed electrician.

exposed wires, recommend repair

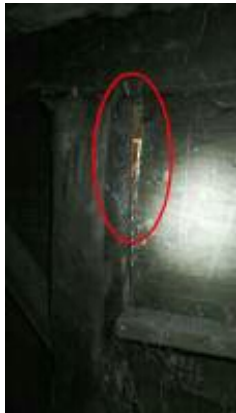
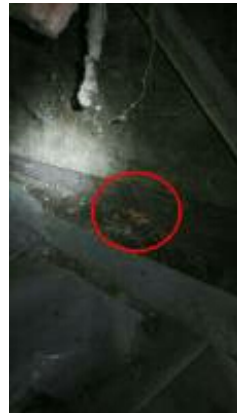
Comments Recommend sealing or installing wire mesh at gaps in plywood skirts around home(see photos). Rodent traps present with 2 captured. Recommend pest inspection.

Gap in plywood skirting around base of home.

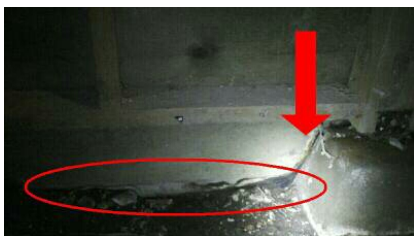
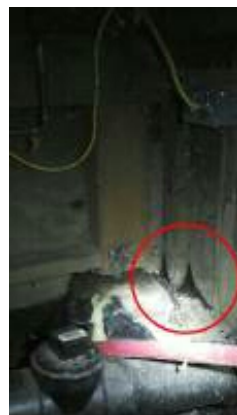
Comments Concrete block foundation at Southeast corner appears to have some structural movement. Large cedar tree roots may be affecting the foundation in this corner. Recommend sealing & monitor(see photo). Plywood skirting in contact with soil & appears to have some moisture staining. Recommend clearing soil away from wood & repair / replace as needed.

wood to soil contact

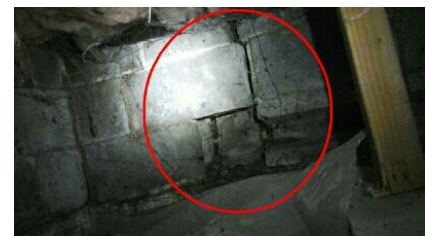
Southeast corner foundation

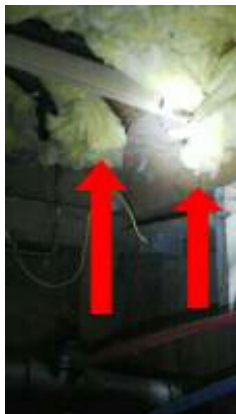
Comments Insulation missing or displaced in some areas. Recommend repair

missing / displaced insulation

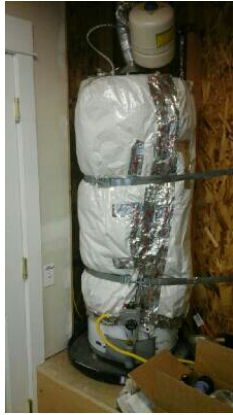
Comments Inspection was limited due to insulation wrap around water heater.

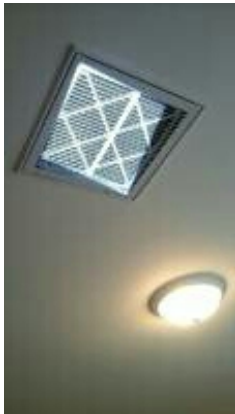
- Heat pump** N/A
- Sub-slab ducts** N/A
- System not operated due to** N/A
- Comments** Heat exchanger had some rusting and corrosion but showed no major defects; flames appeared normal.
 Recommend a qualified HVAC technician examine / service.
 Intake air filter is
 dirty & should be changed every other month or as needed.

dirty filter

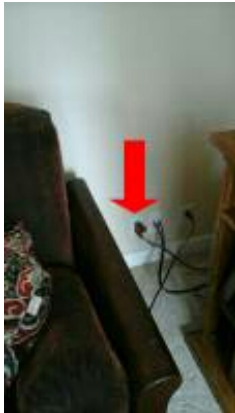
Comments Electrical outlet tested was not operable. Recommend repair by licensed electrician(see photo).

Outlet not operable
